CHAPTER 17

PROTECTION OF THE HYDROLOGIC BALANCE

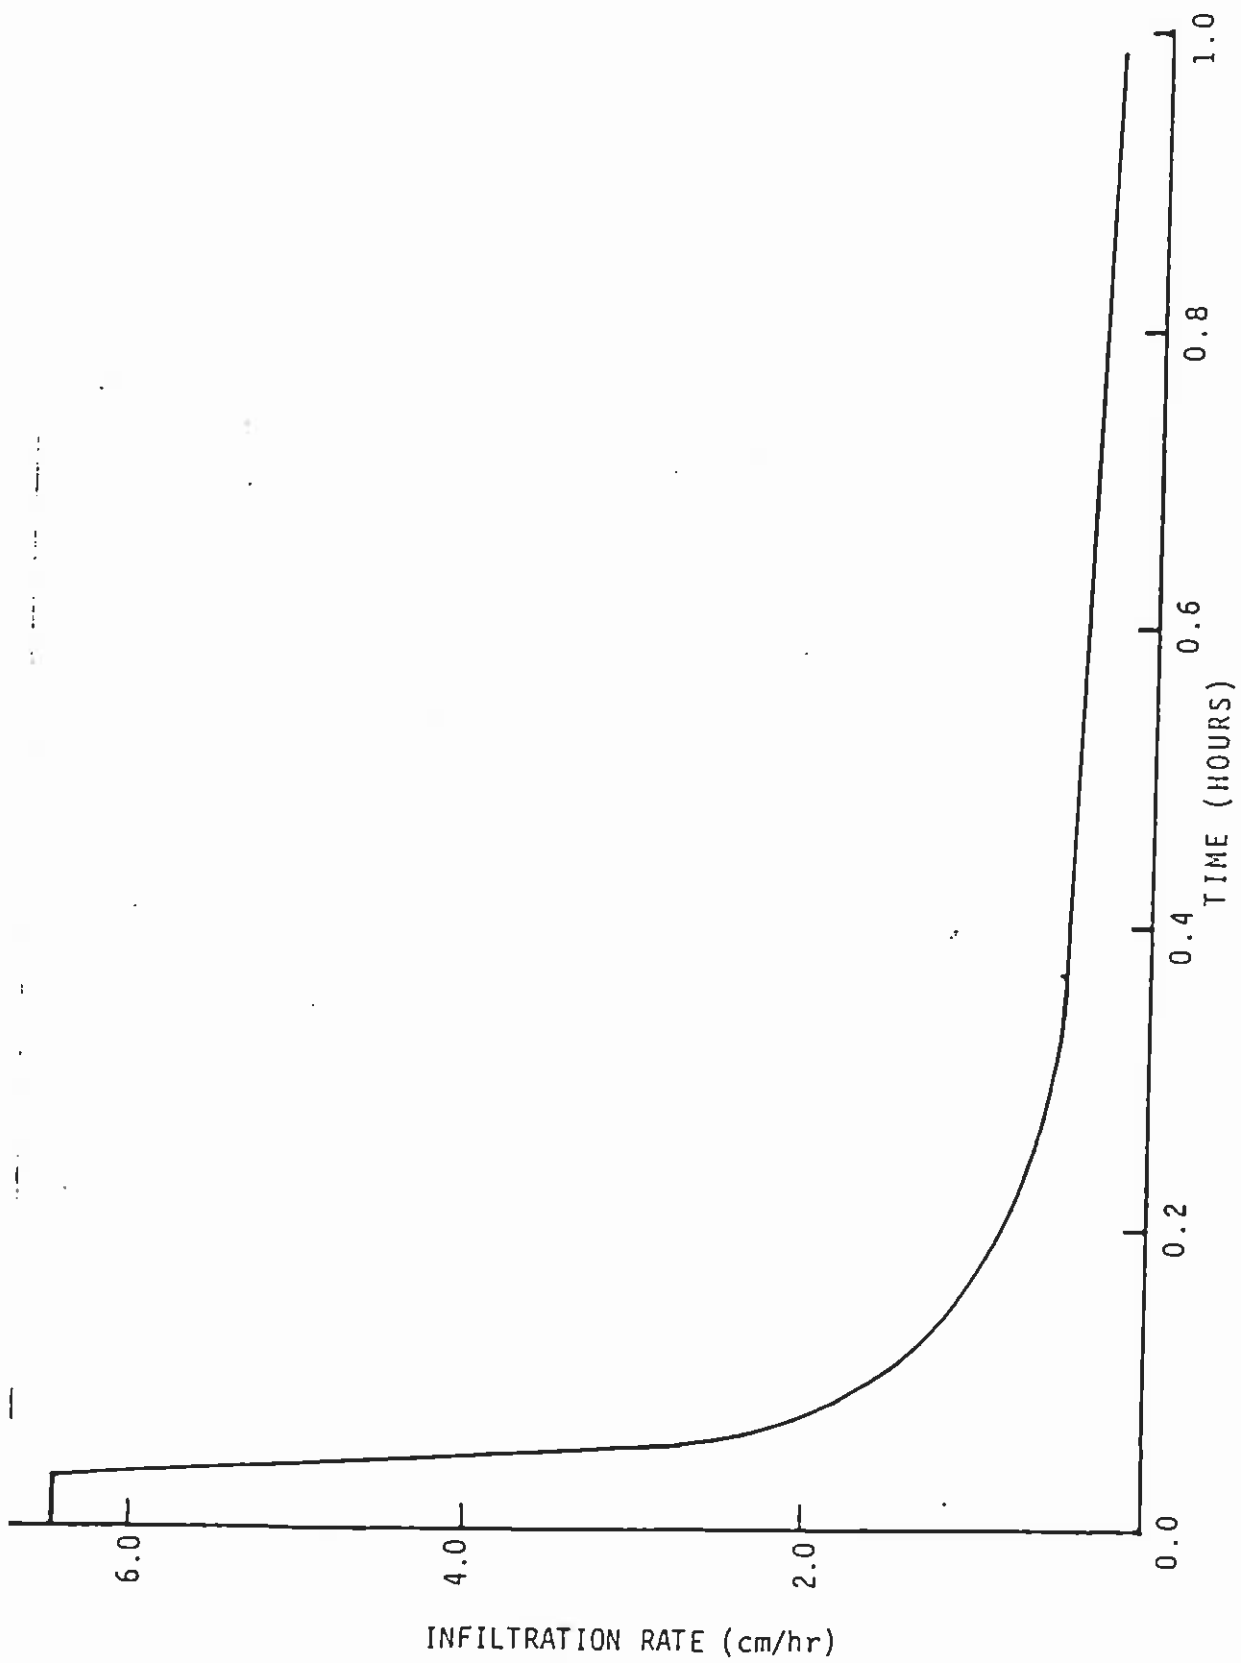
FIGURE 1 AVERAGE INFILTRATION CURVE FOR  
REPLACED SPOIL MATERIAL

Several infiltration tests were performed on the spoil material utilizing sprinkler-type infiltrometers which simulate terminal rain drop velocities. The infiltrometer was constructed and tested at the Water Resources Research Center at the University of Arizona. In the Black Mesa tests, water was applied at a rate of 6.35 cm/hr per hour for a one-hour period. An infiltration curve representing an average of all the infiltration curves is shown in Figure 1. Infiltration rates ranged from over 6 cm/hr for the first .1 of an hour to less than 0.13 cm/hr at the end of the one-hour tests (Berkas, 1978). Table 1, taken from the ASCE Manual of Engineering Practice No. 28, shows that the replaced spoil material would fall into the low infiltration rate category. Though the spoil showed low infiltration rates, many of the soils and the bedrock comprising the Wepo formation also show low infiltration potential. The foregoing discussion shows the principal process by which spoil will recharge is from lateral inflow from surrounding portions of the undisturbed Wepo aquifer and undisturbed burn areas.

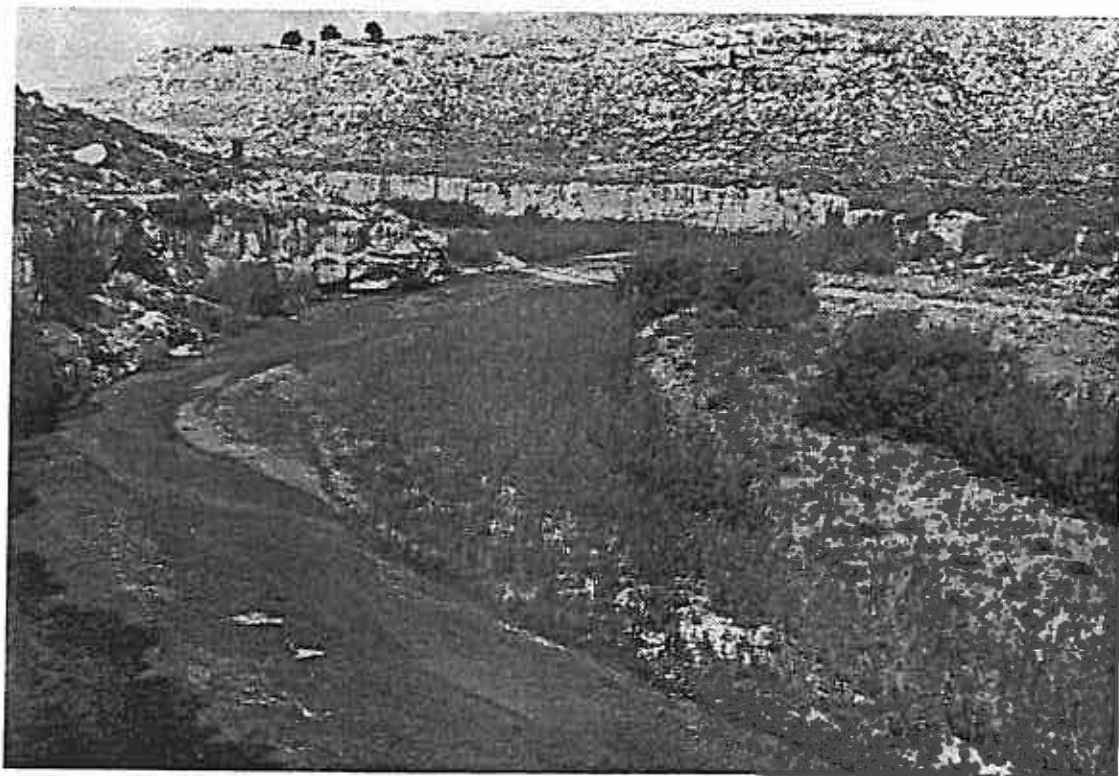
Figure 3  
Typical Location of True Phreatophytes Adjacent  
to the Active Channel Waterline

The IMS, Inc. report found that three of the species that may occur as phreatophytes in the coal regions of the western U.S. (according to "Alluvial Valley Floor Identification and Study Guidelines", OSM, 1983) were found in either the riparian or mixed shrub vegetation types. However, IMS concluded that the presence of greasewood and four-wing saltbush on the alluvial terraces above the active drainages and flood-plains does not indicate phreatic conditions that would enhance subirrigation. The only true phreatic indicator on the leasehold is salt cedar and it was only found adjacent to the active channel waterlines (see Figure 3), not on the terraces.

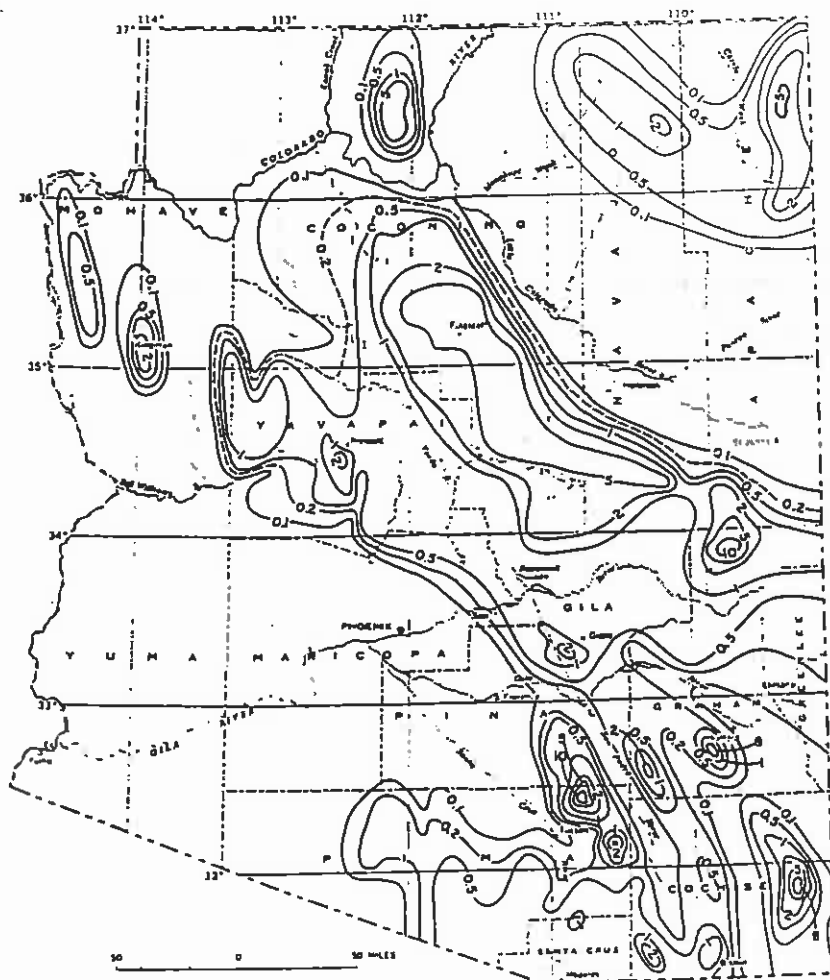
Average Annual Water Yields. A final concept to be discussed is average annual water yields. An average annual runoff map for the different regions of Arizona has been developed by the USGS. This map, showing isopleths of average annual runoff, is presented in the 1969 Arizona Bureau of Mines Bulletin 180, Mineral and Water Resources of Arizona (Figure 4).

For the Peabody leasehold, average annual runoff values range from .5" to 1.0". Using the data presented by Sellers and Hill (1977), the percentage of the average annual rainfall that occurs during the 5-month growing period in northeastern Arizona is 51%. Multiplying this percentage by the average annual yield values gives average 5-month yield values of .255" to .51". Assuming uniform runoff over the four principal washes draining the leasehold, average 5-month yields have been calculated and are presented in Table 7.
