| DRAWN BY: PCC | REVISION: 9-15-92 | SCALE: HORIZ: 1"=100' | SHEET 1 OF 2 SHEETS | PEABODY COAL COMPANY<br>1300 SOUTH YALE, FLAGSTAFF, AZ 86001 |

| DRAWING NO. 85440<br>J-19 HAUL ROAD - NORTH LEG OF WYE<br>KAYENTA MINE | | | |

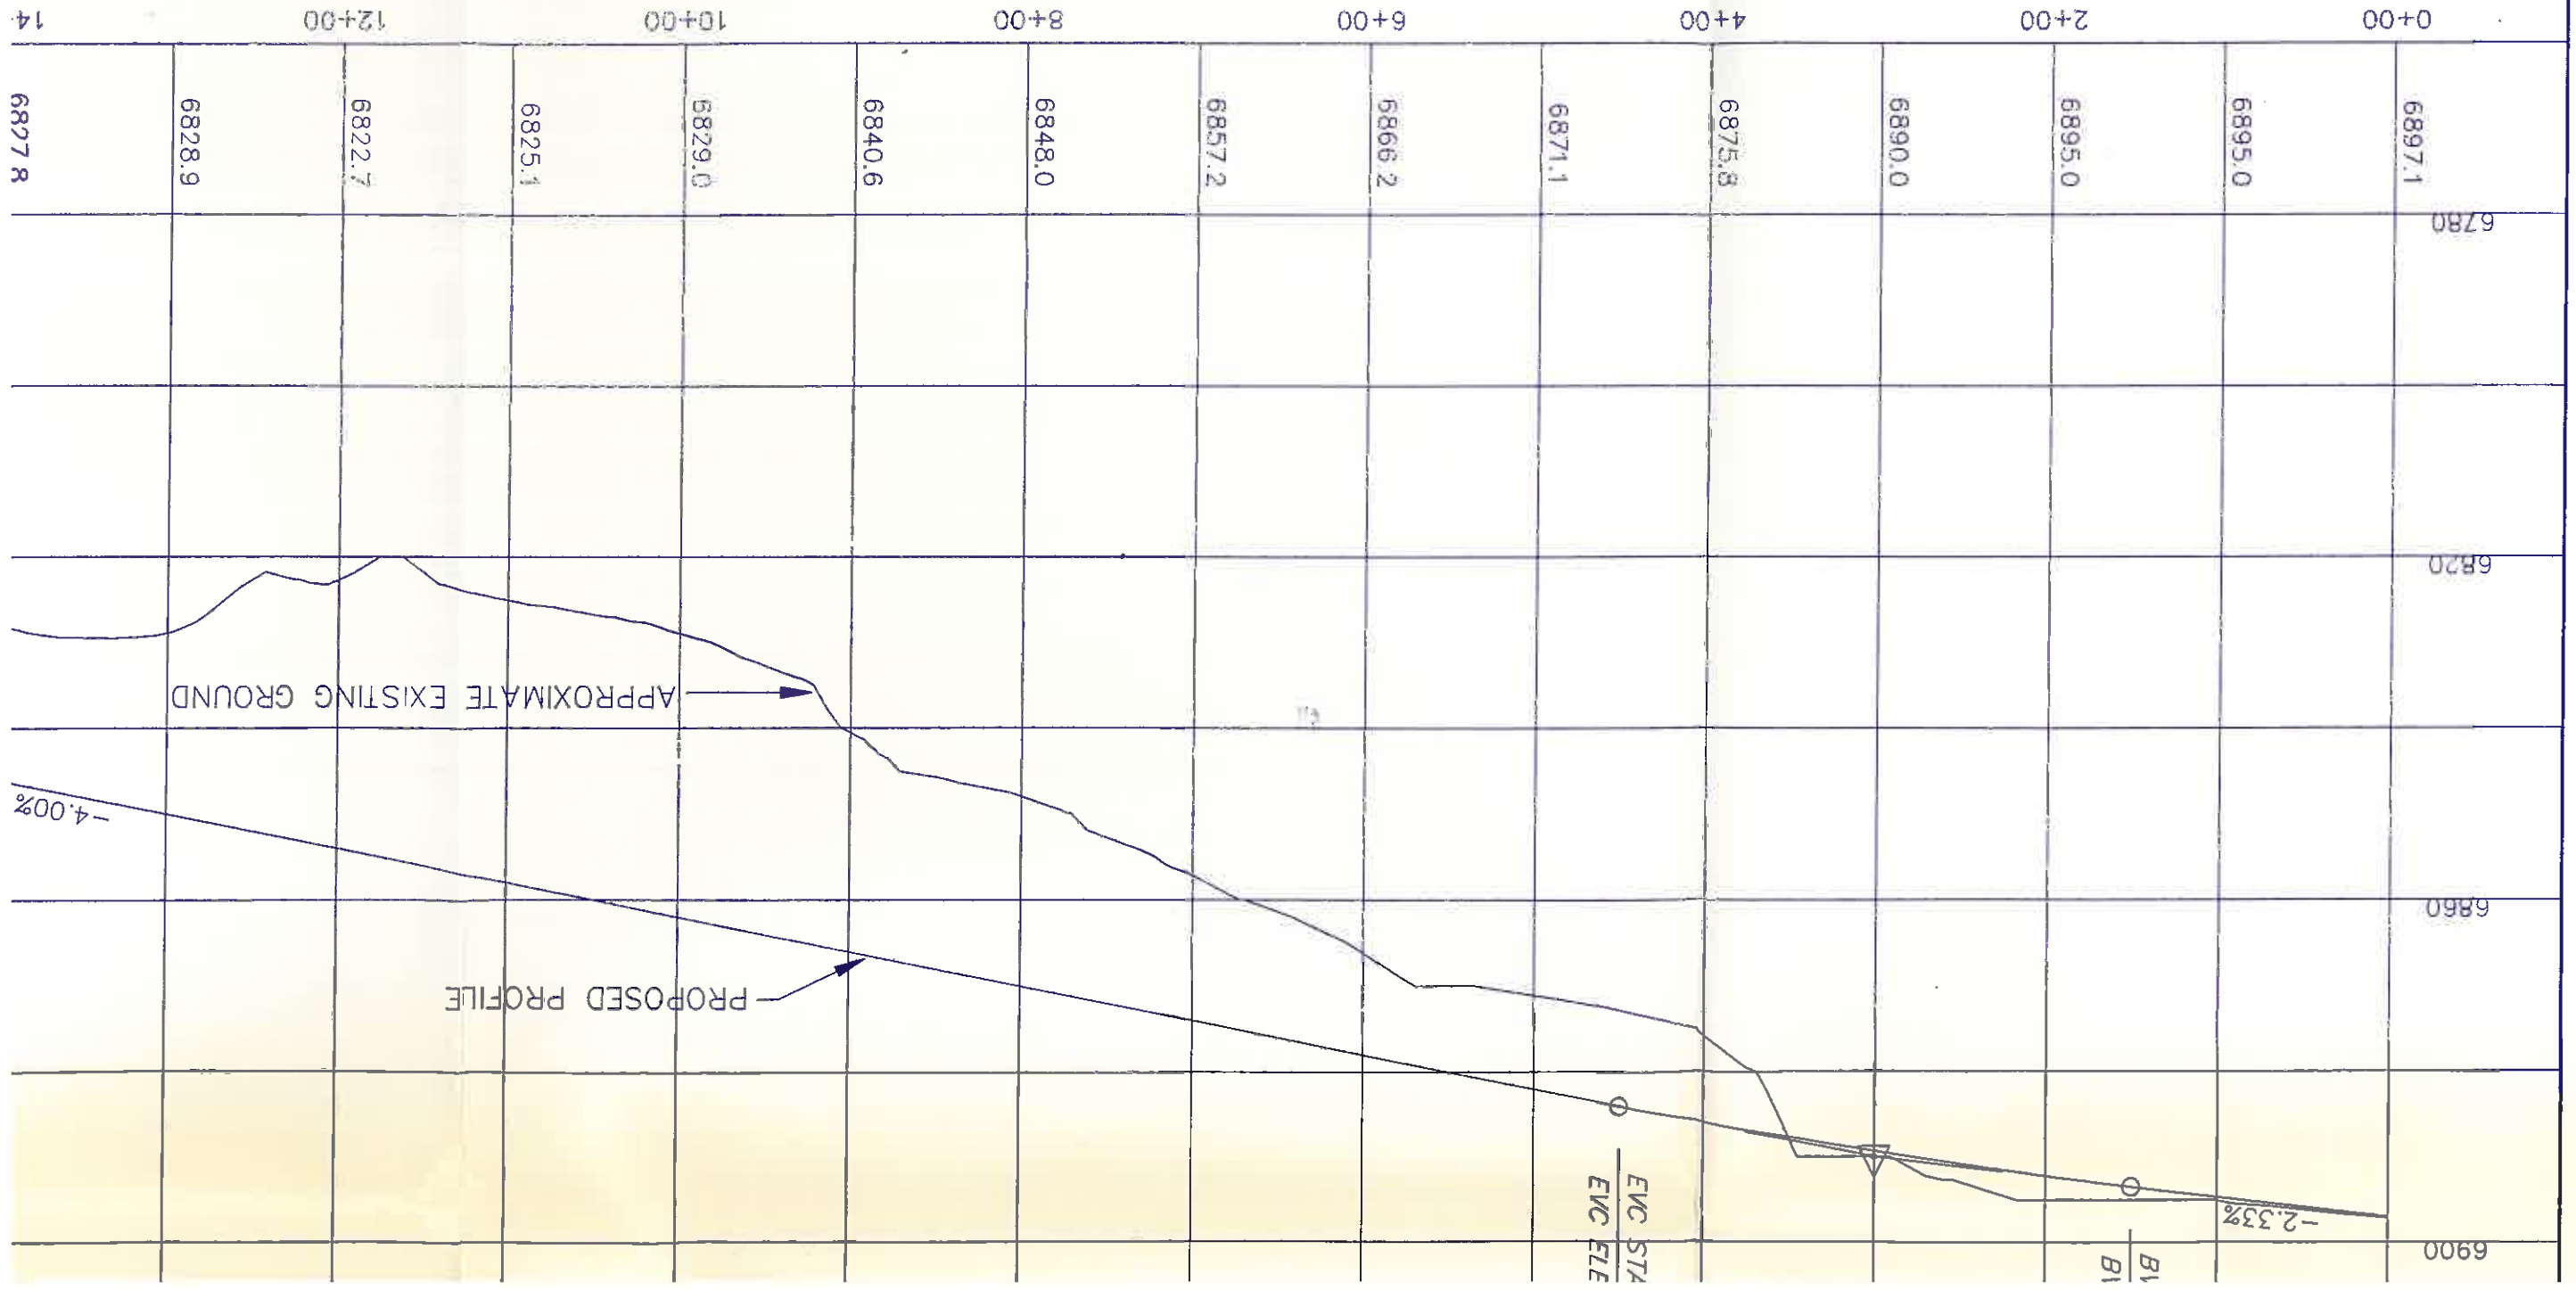
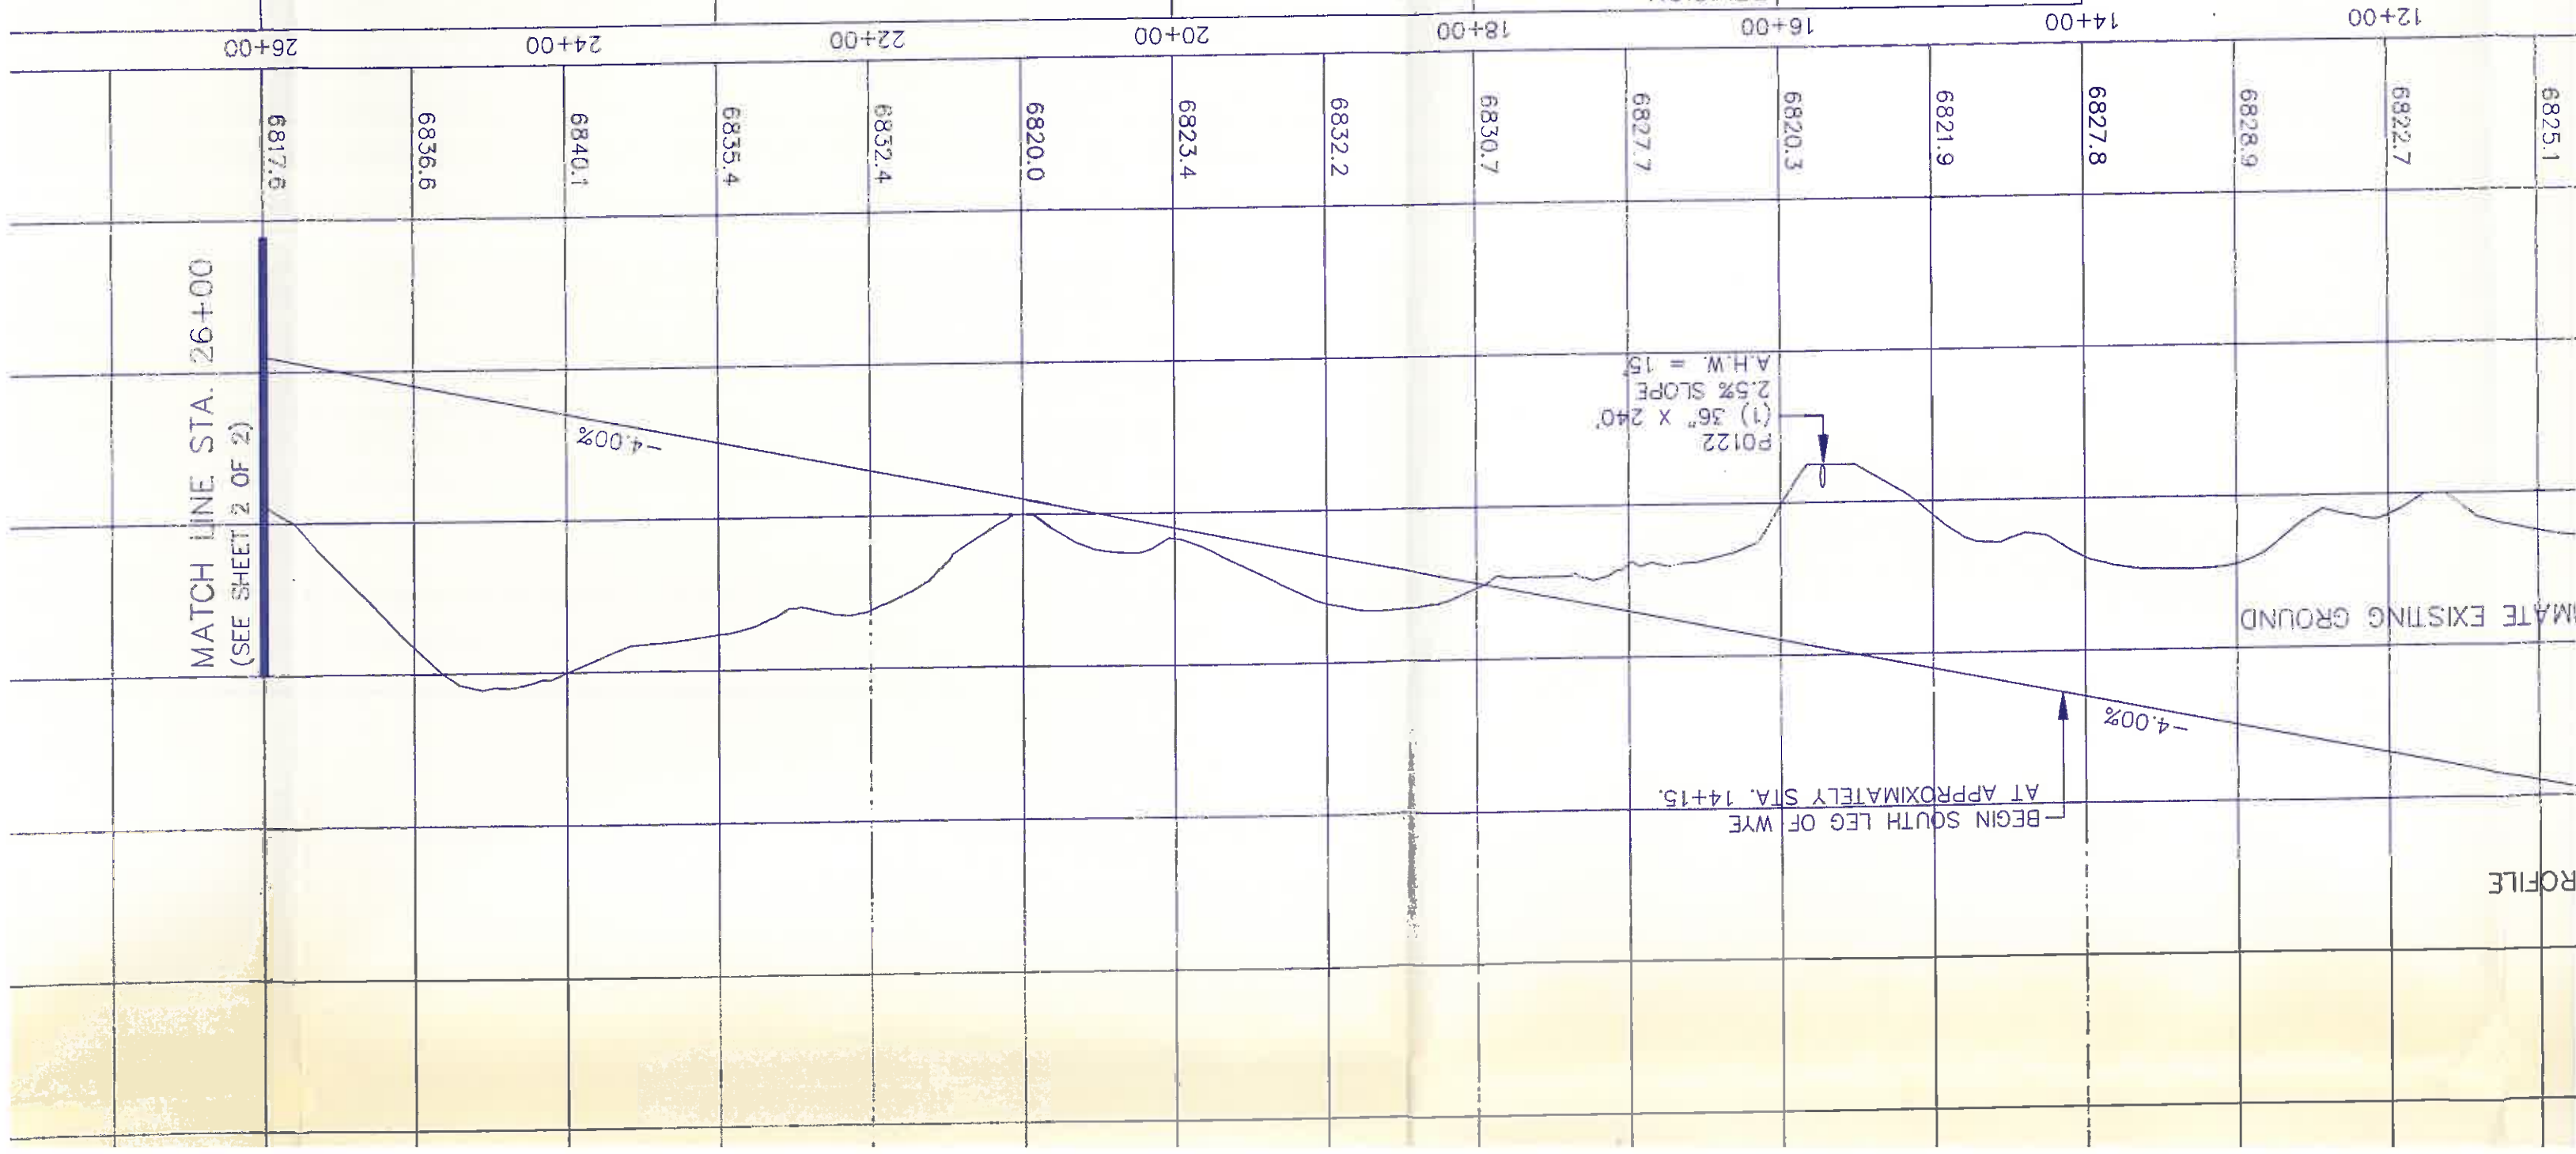
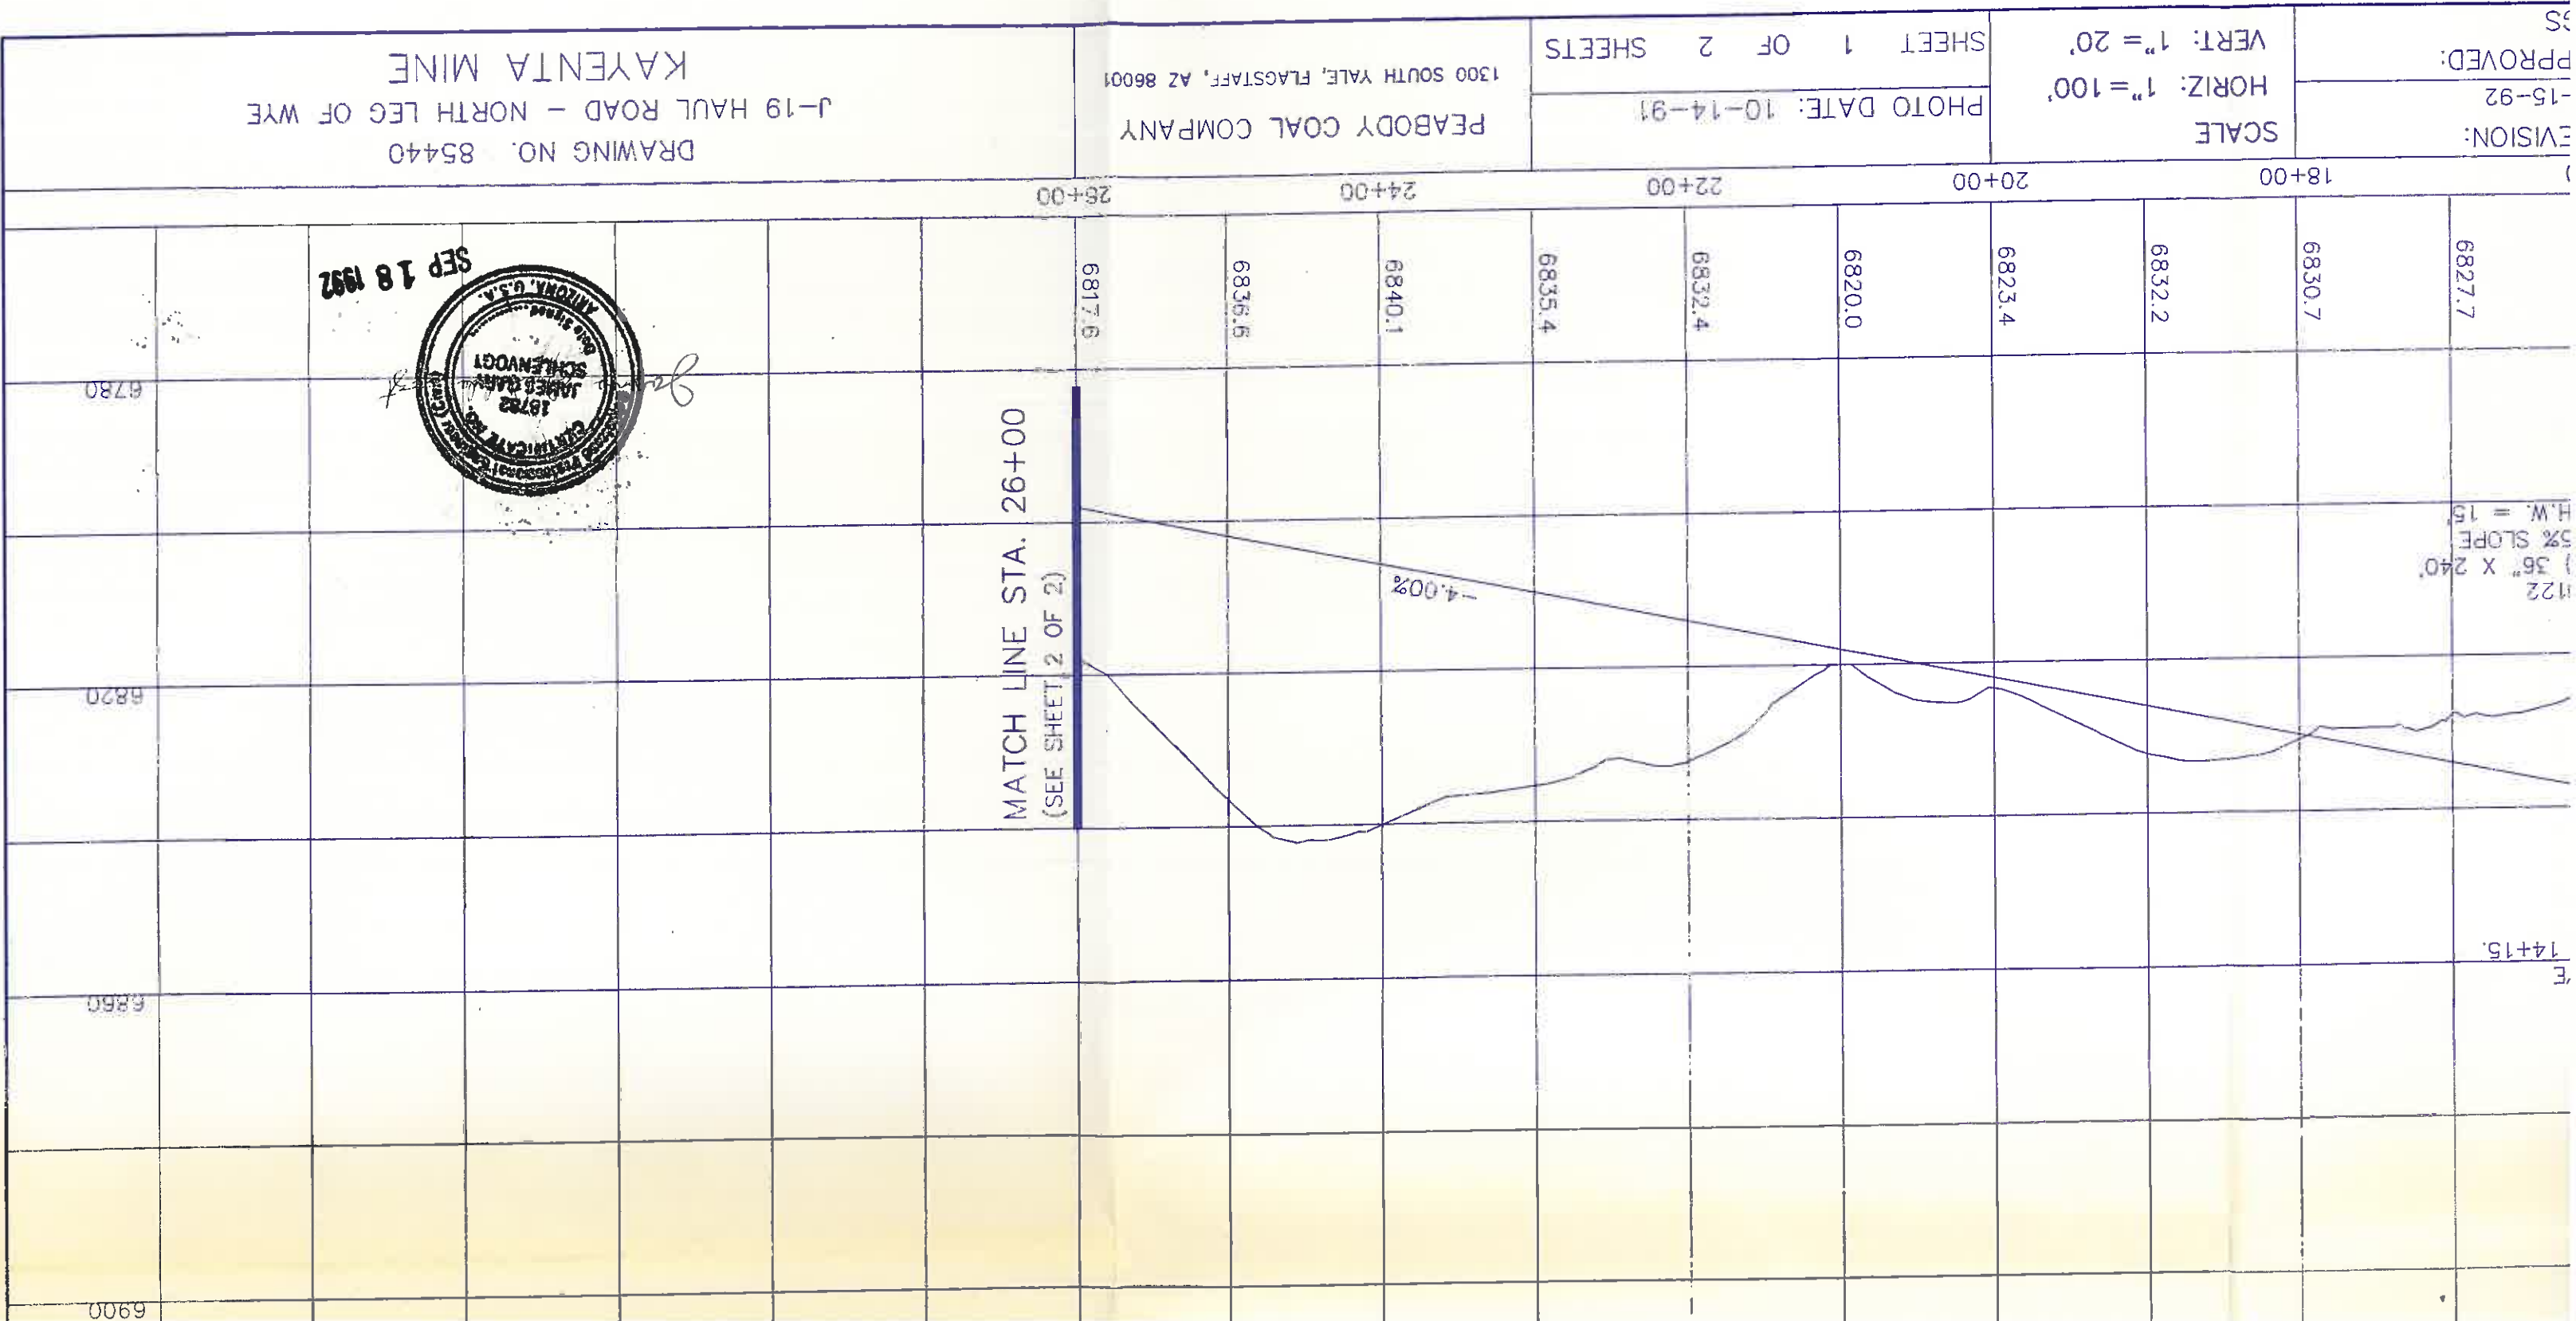
- NOTES:
- A-A' (See Chapter 6, Figure 26 for Typical Cross-Section.  
Design width = 75').
  - See Black Mesa PAP Chapter 6 for Construction Specifications.

- See Chapter 6, Attachment N, Volume 7 for Black Mesa Complex Geotechnical Inspection Report.
- Salvage topsoil in accordance with the approved topsoil salvage plan.
- Reclamation of the road side slopes and the associated disturbance shall be in accordance with the approved reclamation plan.
