| DRAWN BY: PCC | REVISION: 9-15-92 | SCALE: HORIZ: 1"=100' | SHEET 1 OF 2 SHEETS | PEABODY COAL COMPANY<br>1300 SOUTH YALE, FLAGSTAFF, AZ 86001 |

| DRAWING NO. 85440<br>J-19 HAUL ROAD - NORTH LEG OF WYE<br>KAYENTA MINE | | | |

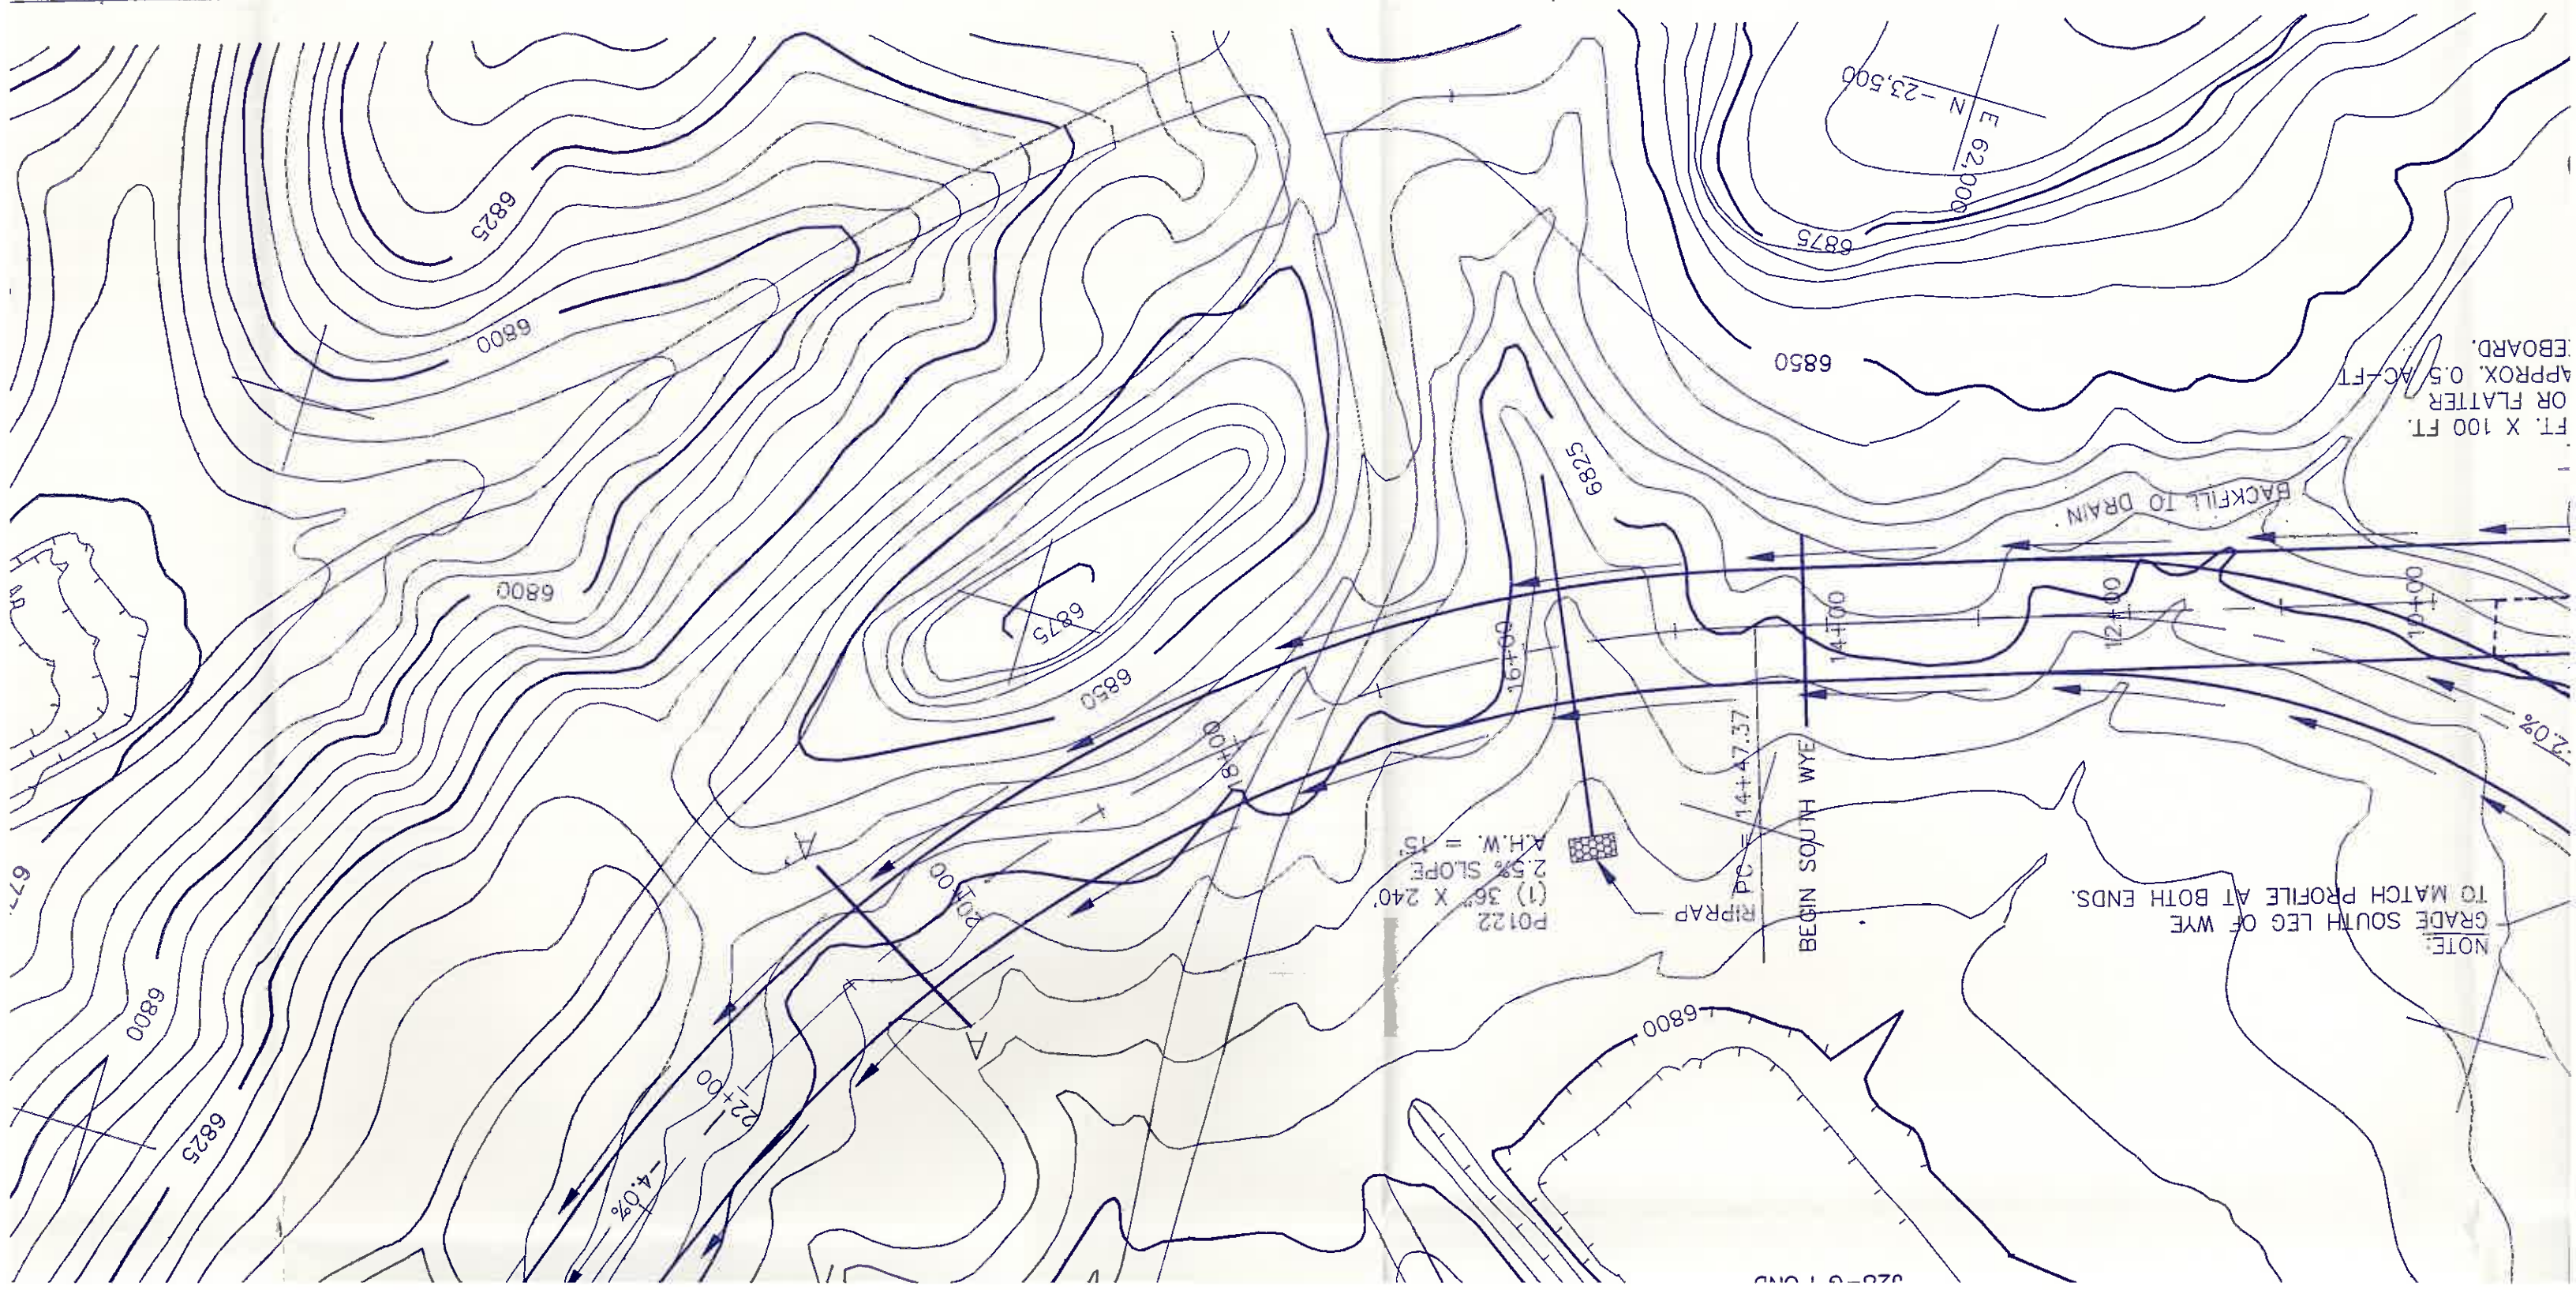
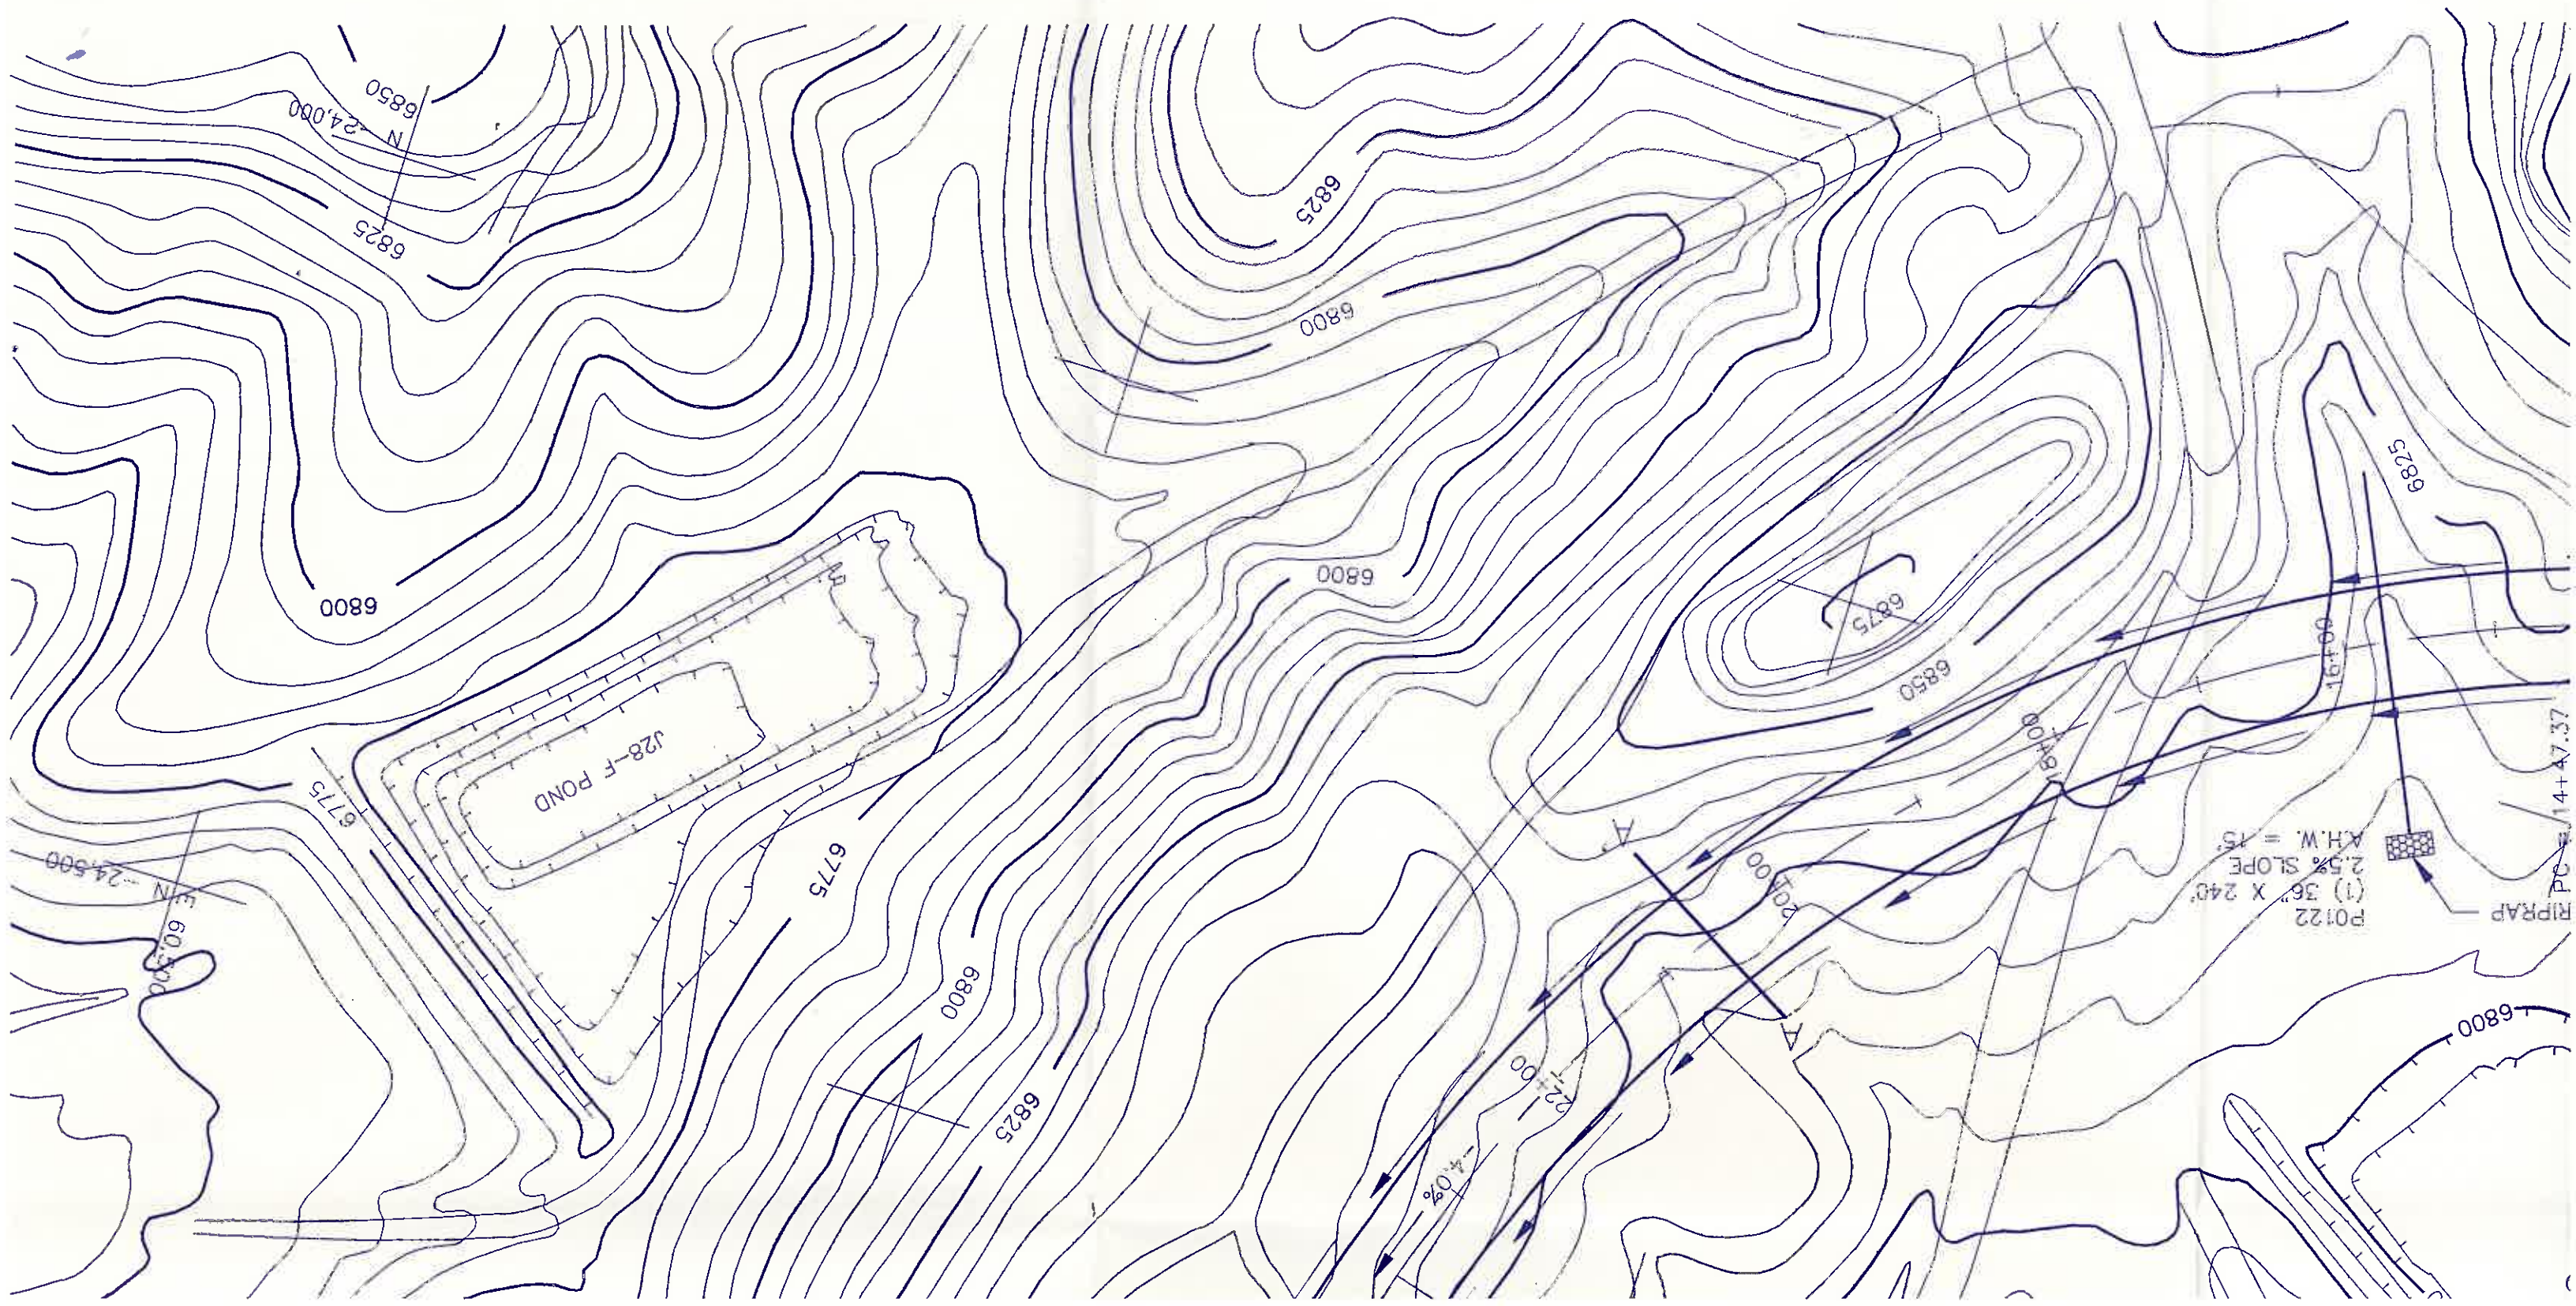
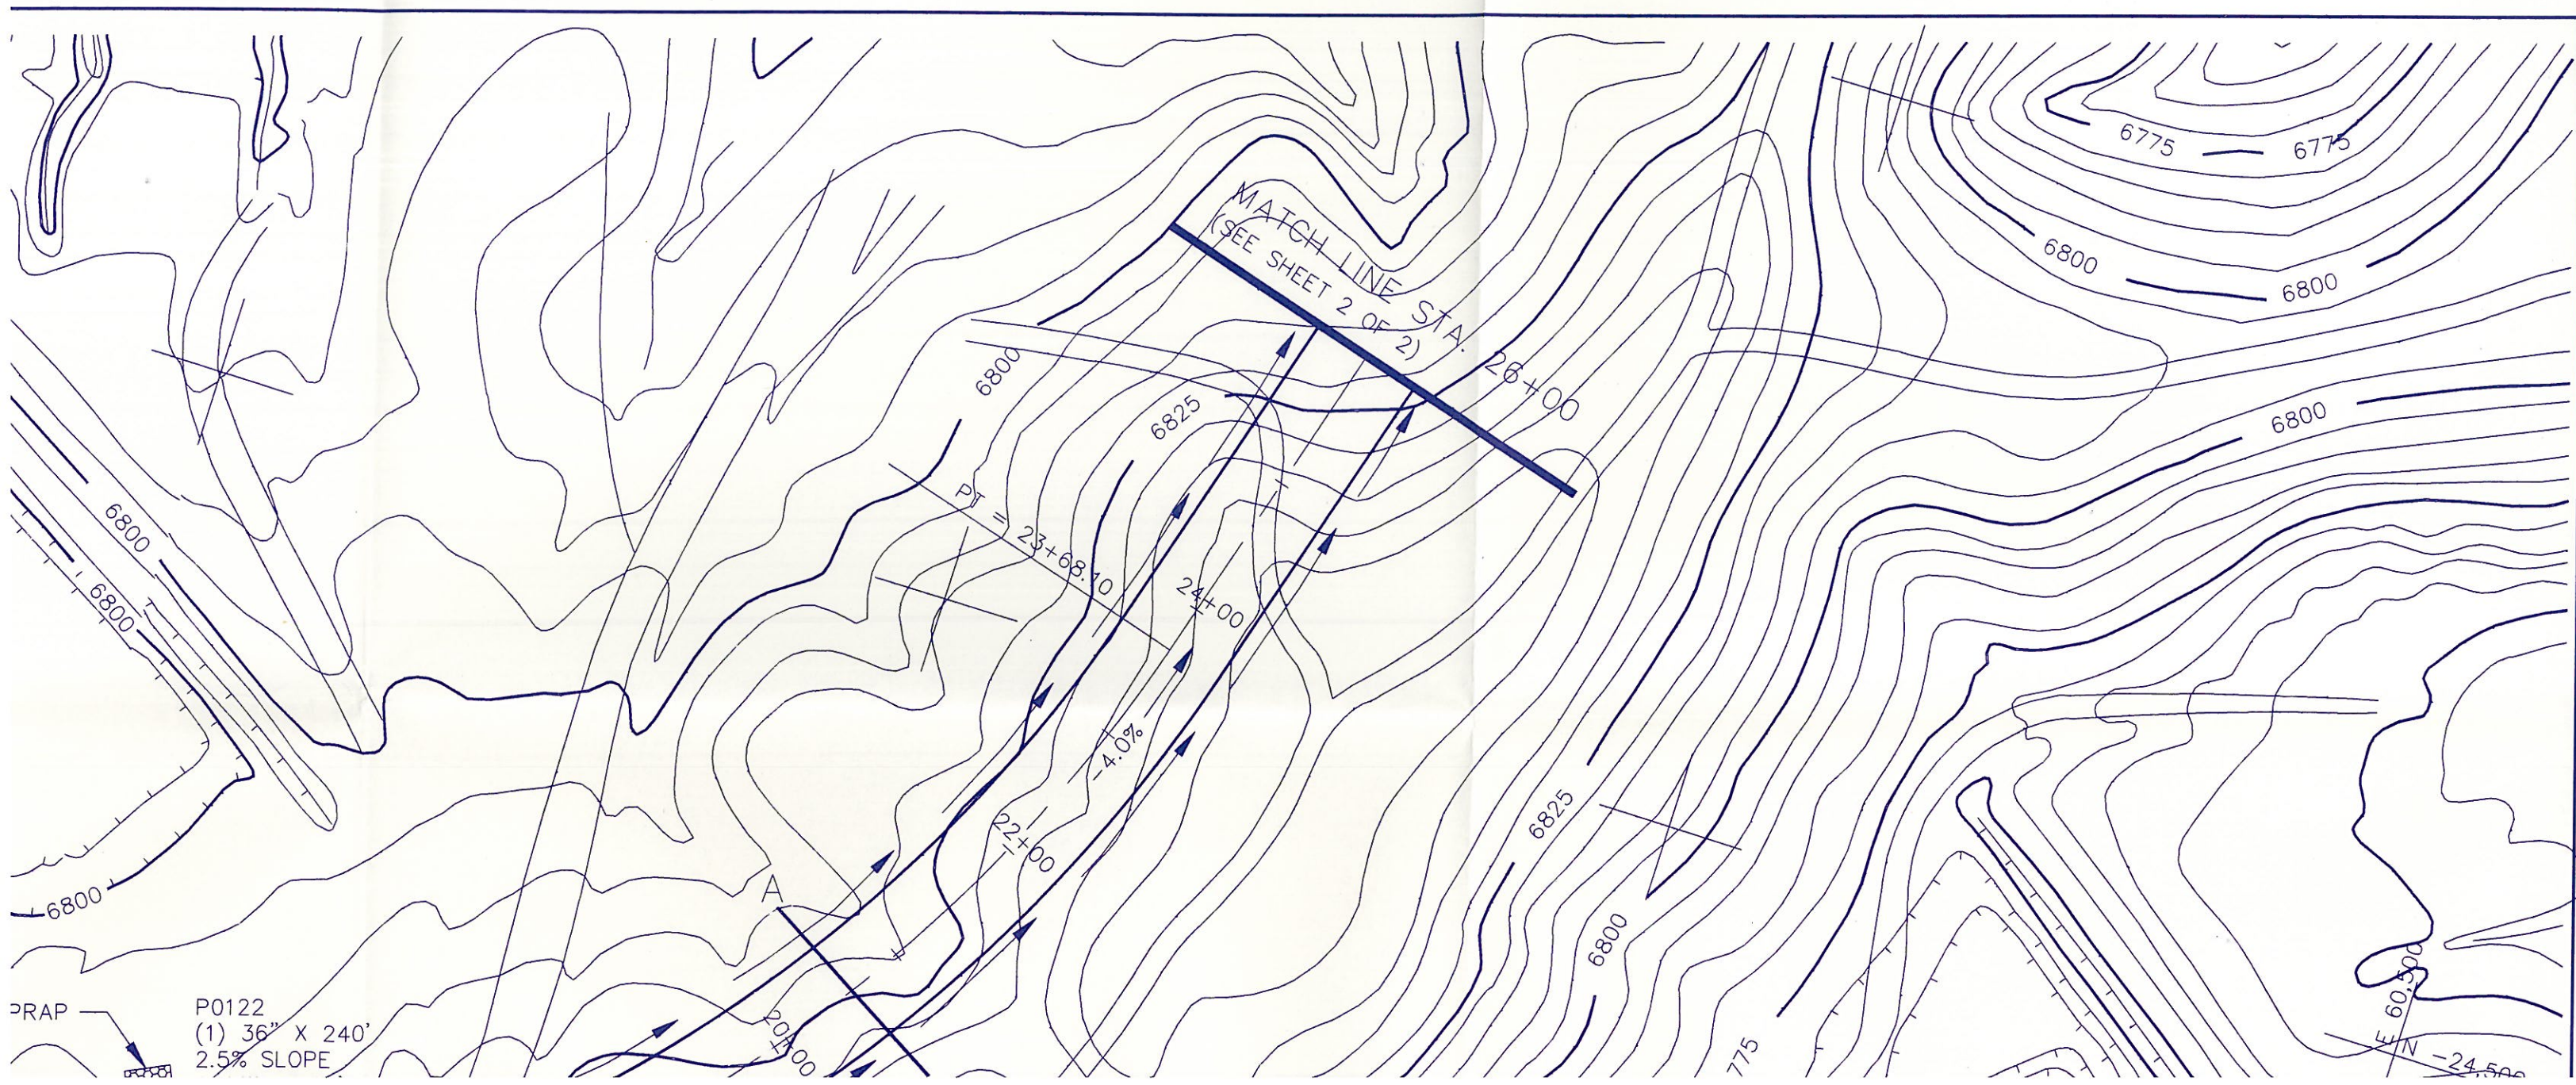
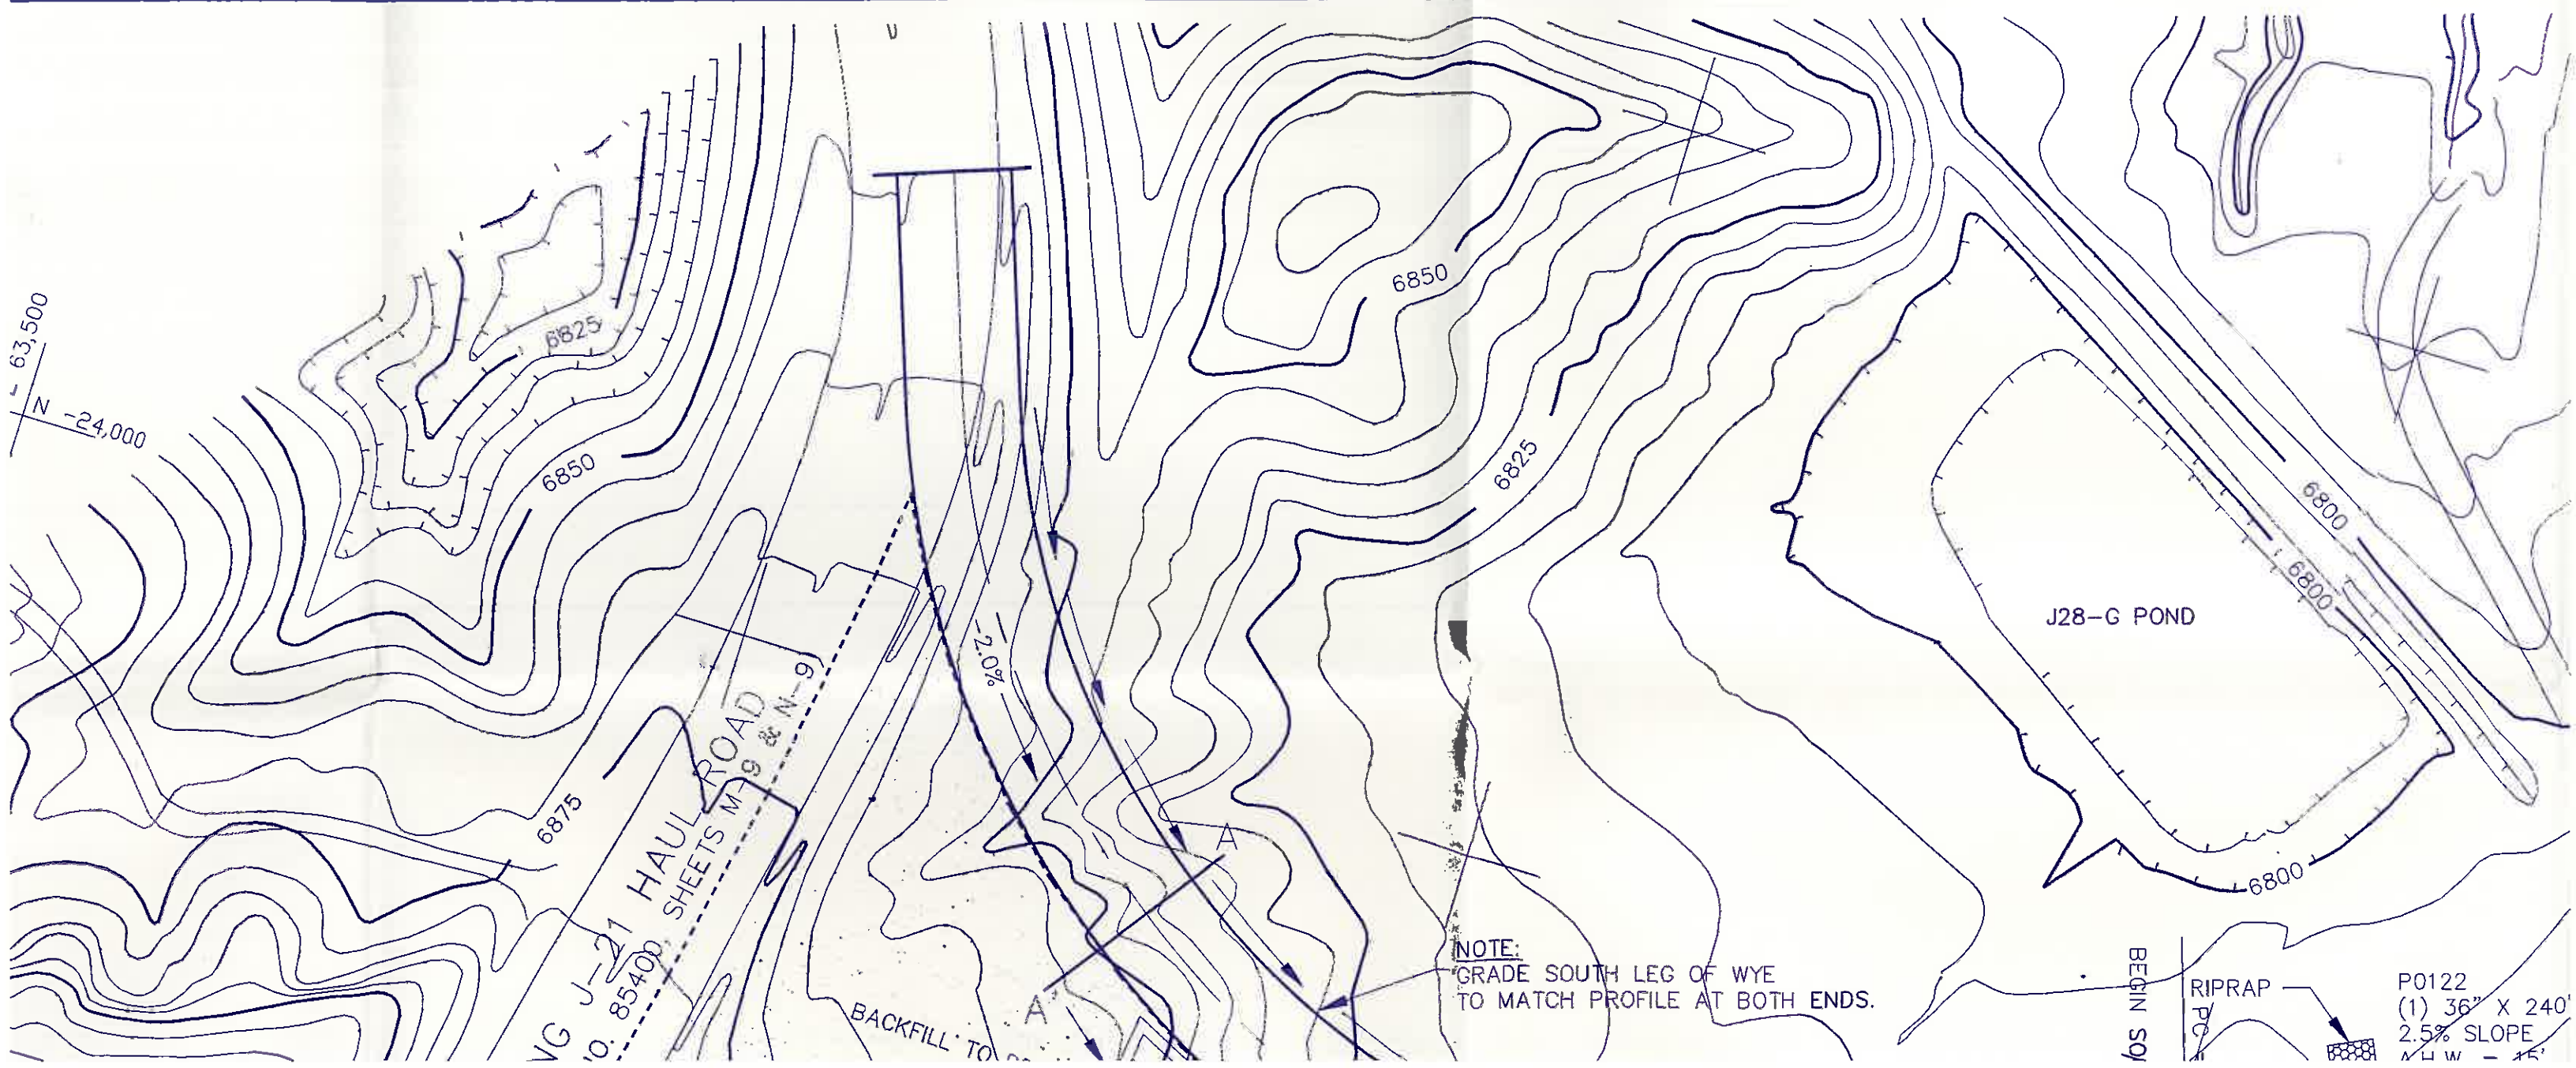
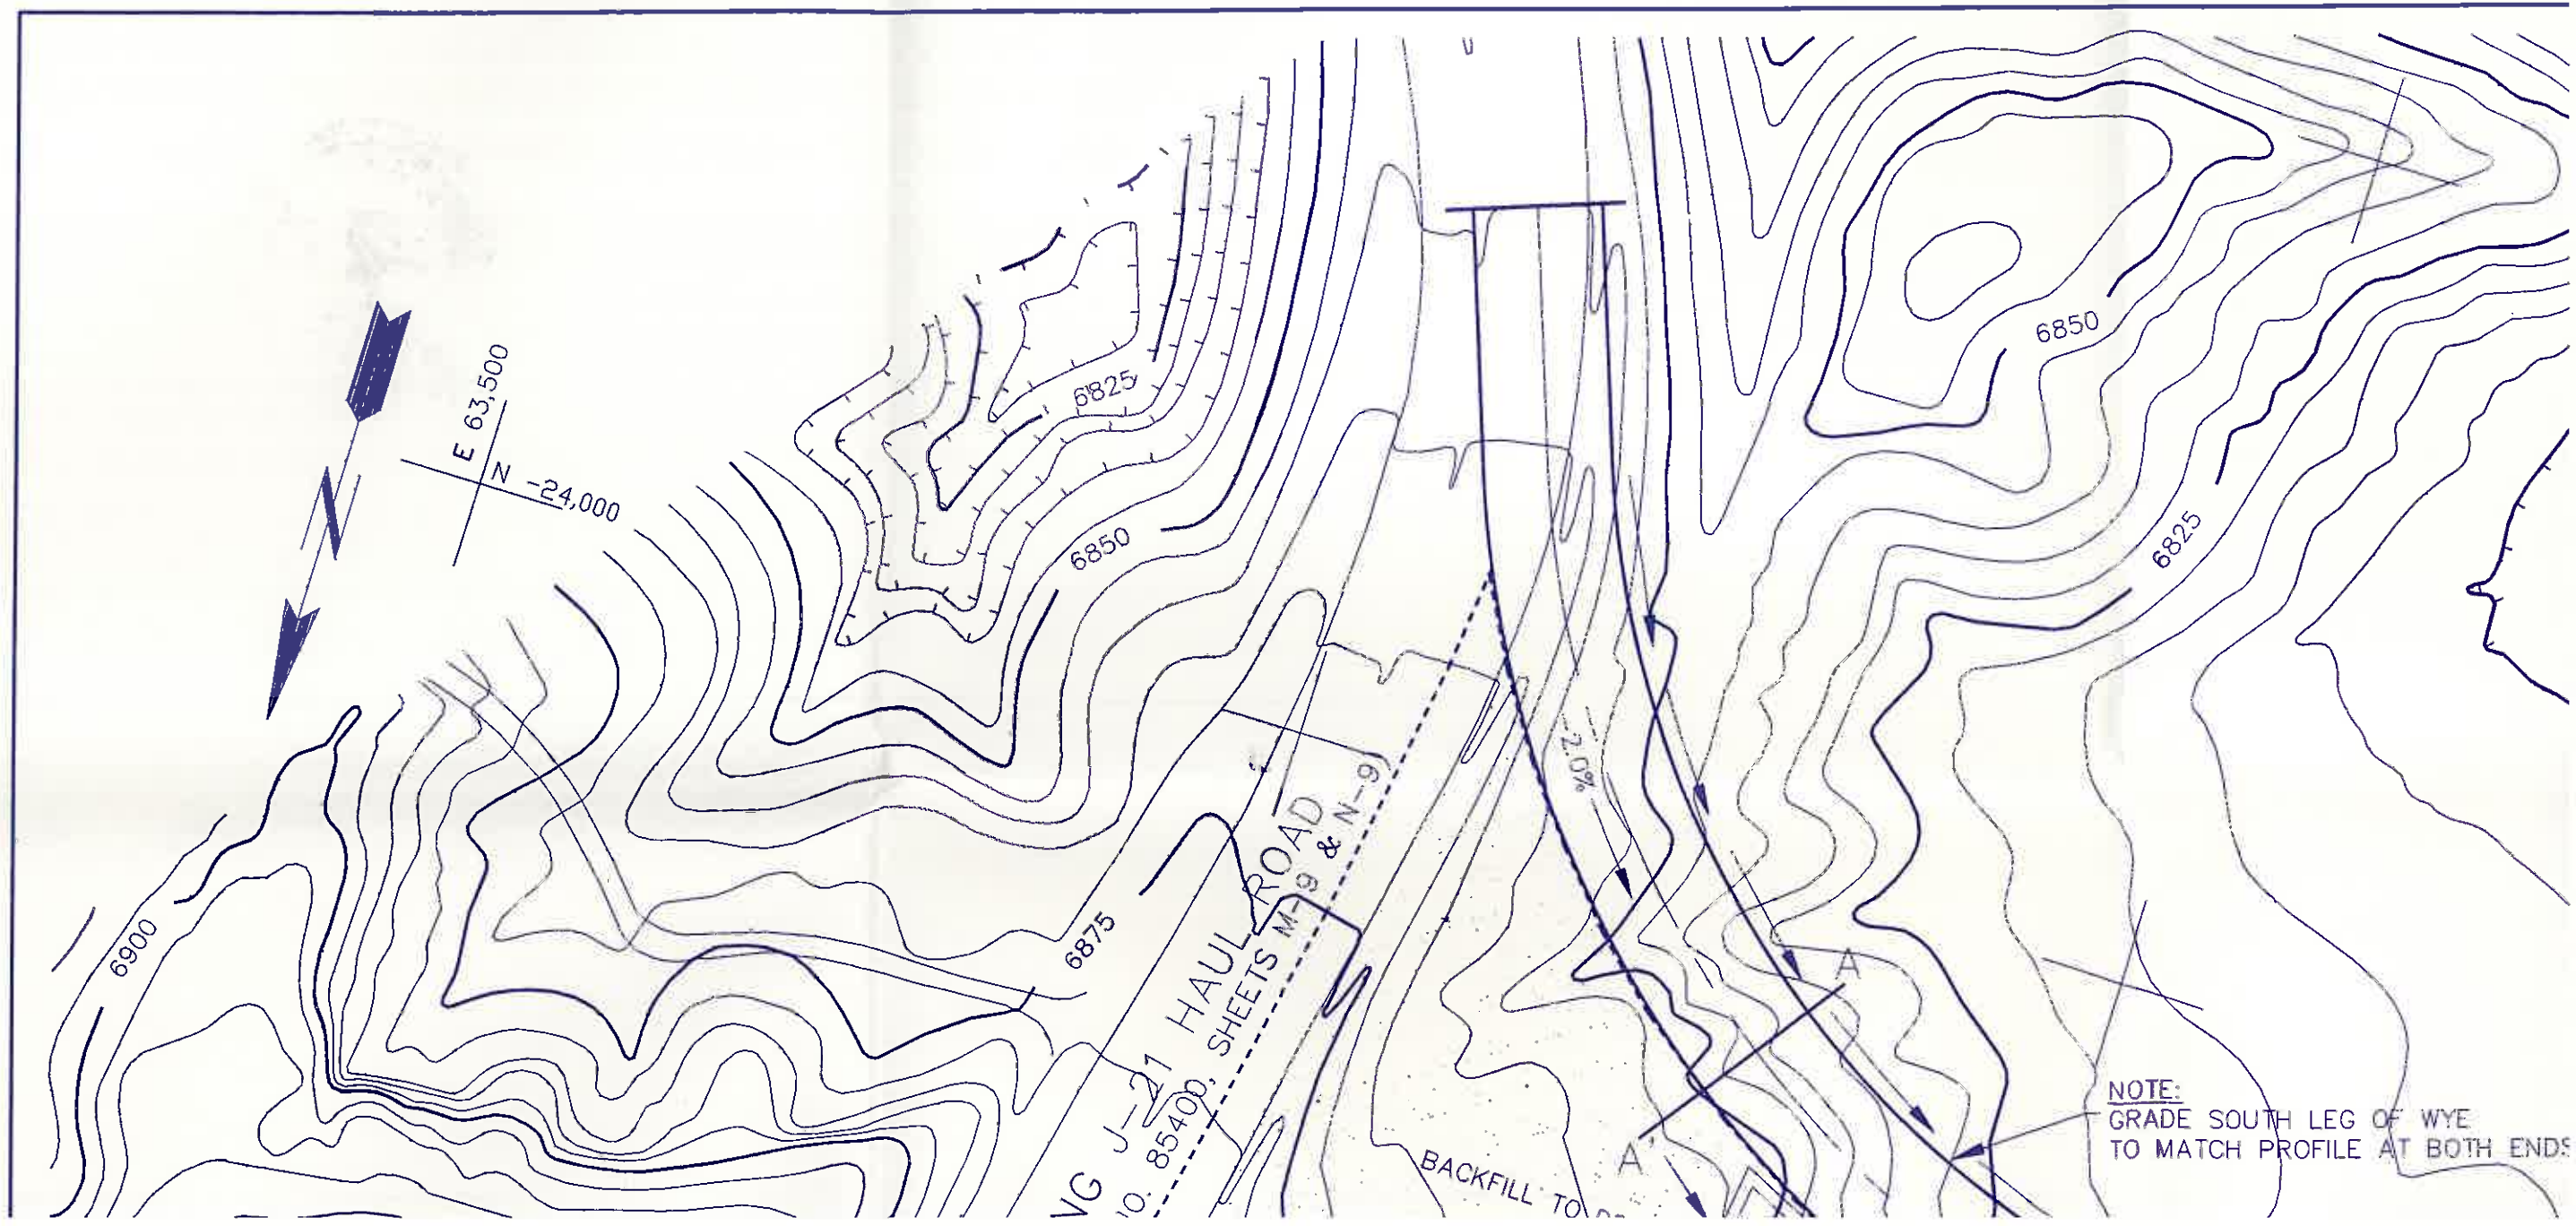
NOTE:  
GRADE SOUTH LEG OF WYE  
TO MATCH PROFILE AT BOTH ENDS.

BEGIN SQ  
RIPRAP  
P0122  
(1) 36" X 240"  
2.5% SLOPE  
N L W - 15'
